10 Henry Street,
Kirriemuir,
Angus,
DD8 5DL

Home Report

Single Survey

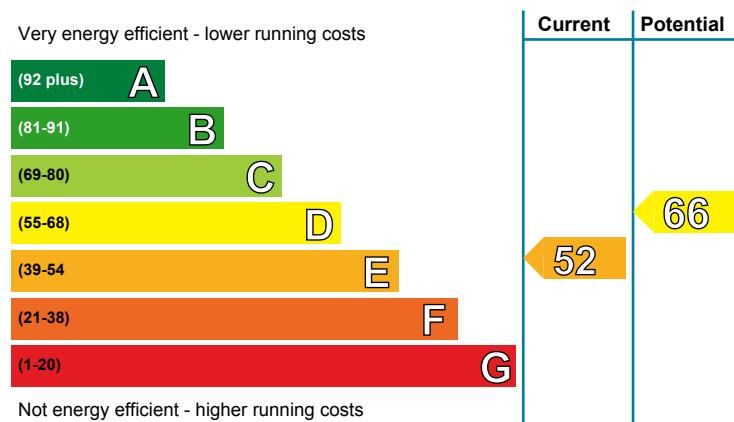
Energy Efficiency Rating

This graph shows the current efficiency of your home, taking into account both energy efficiency and fuel costs. The higher this rating, the lower your fuel bills are likely to be.

Your current rating is **band E (52)**. The average rating for EPCs in Scotland is **band D (61)**.

The potential rating shows the effect of undertaking all of the improvement measures listed within your recommendations report.

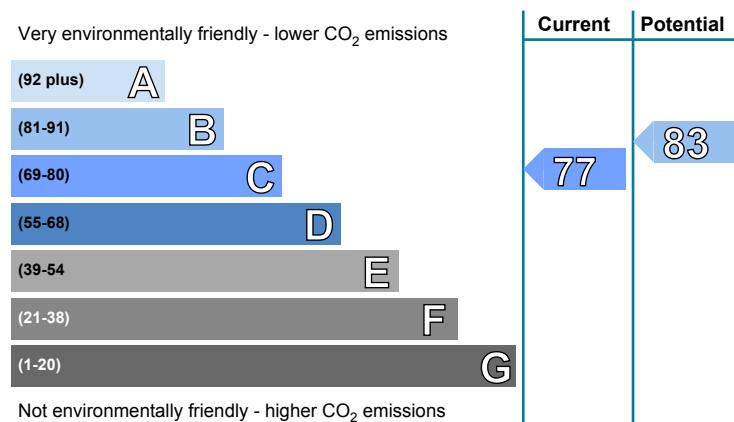
Environmental Impact (CO₂) Rating

This graph shows the effect of your home on the environment in terms of carbon dioxide (CO₂) emissions. The higher the rating, the less impact it has on the environment.
